Fox Cities Exhibition Center

Weekly Update - 03/20/2017

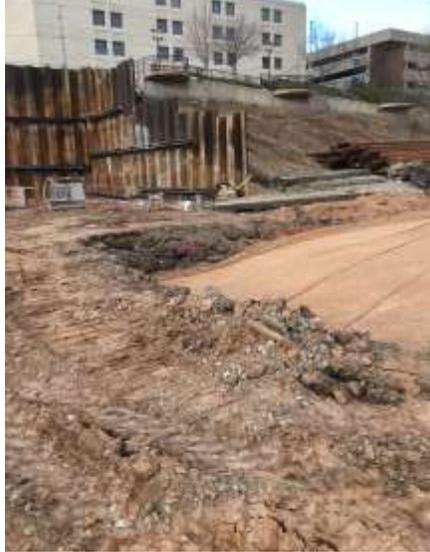
Location of the large existing footing; it was removed and backfilled to allow the pipe piling to be installed.

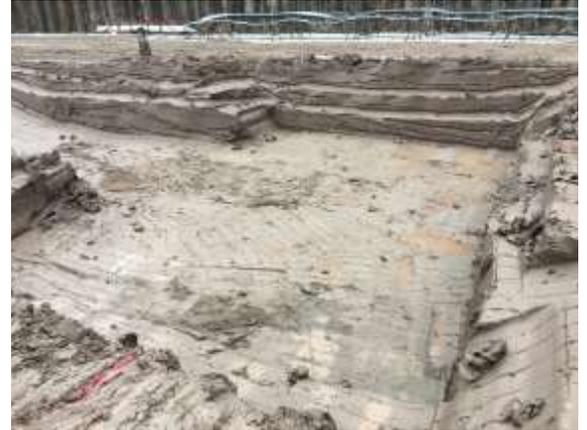
Location of the future freight elevator. This was dug out to allow access for the drill rig coming Monday morning to drill the hole for the hydraulic lift of the elevator.

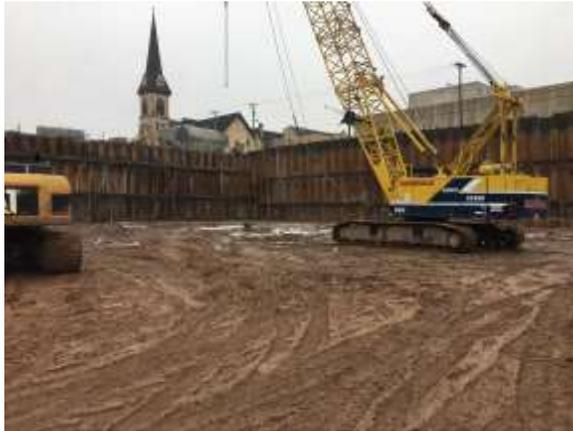
View into the northwest corner of the building footprint. Once completed, this view will be looking into the exhibition hall.

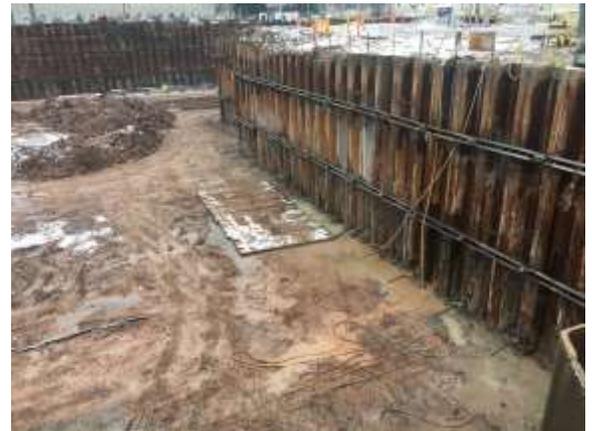
View of the Elm Street side of the project. The majority of the tieback anchors are installed, except for a few that will require a duplex auger to cut through the old foundations buried in the soils.

- ◇ **Tieback Anchors/Pipe Piling:** *Tier 3 tieback anchors were nearly complete by the end of the week, leaving only the northwest corner and the Elm Street side to be installed. Michels will utilize their duplex drill to work through the existing buried footings, which caused their normal machine to jam up. The pipe piling test was completed, which will allow the rest of the piling to be installed in the very near future.*
